## **Marine Safety Consultants, Inc.**

March 30, 2016  
File No.: 16-0229

### ***ULTRA-SONIC INSPECTION SURVEY REPORT***

Marine Safety Consultants, Inc. has undertaken an ultra-sonic survey of select points on the TASHMOO pump out boat and the VINEYARD HAVEN pump out boat while hauled ashore and trailered in TISBURY, MA on March 28, 2016, in accordance with our February 10, 2016 proposal.

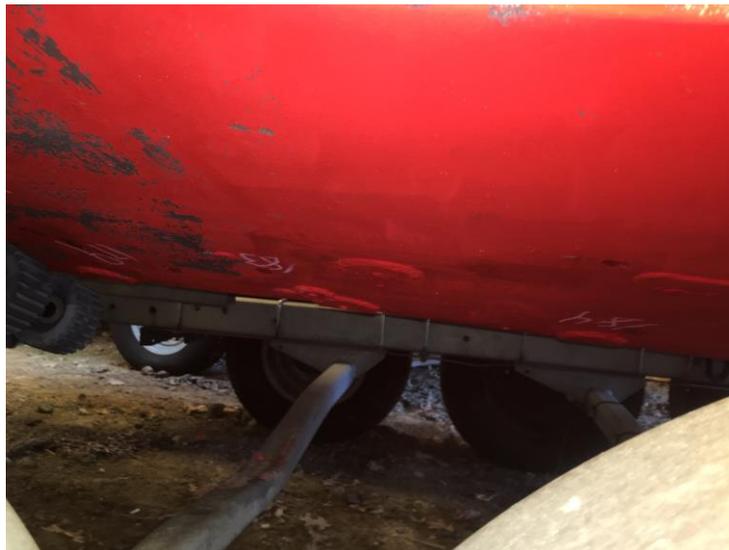
The hull has had several external steel repairs "doublers" on the starboard aft bottom. It had been reported to us that the hull had pits in these areas. Our survey of the hull plate around these locations found the metal to be near full thickness and to be in very good condition with overall wastage near 7%.

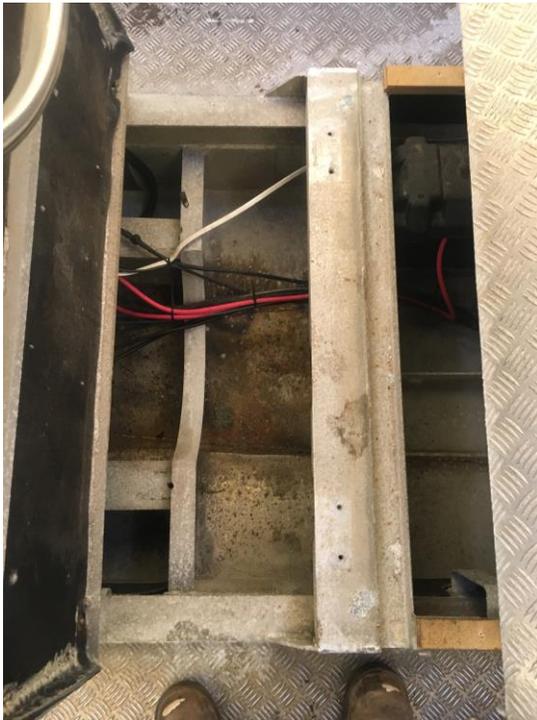
The hull is configured to only have access to one internal compartment which is located below the helm station. A survey of this compartment found light corrosion and a trace amounts of water. We found evidence of light corrosion on aluminum bottom plate consistent with the observed bilge water. We located one (1) heavy pit below vessel wiring which had been repaired by an external doubler. No other heavy pitting was observed from the internal access.

Bilge access from helm hatch

At the time of our survey we found some standing water in only accessible internal void just below the helm. We recommend you consider washing down this bilge space with freshwater and maintaining this space clean and dry to prevent future corrosion and pitting.

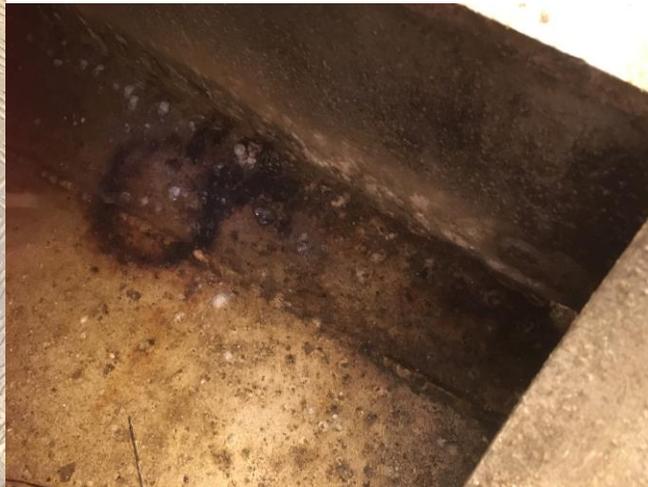
Circular mark is location of old pit and external weld

It has been reported to us that this vessel was once powered by an inboard engine and that there may have been an electrical issue at that time. In addition it is reported that steel bolts had been removed from the bilge when the pits had been discovered. The pits experienced by this vessel in the past could have been directly related to these two (2) previously reported problems.
