Vineyard Land Surveying & Engineering, Inc.

CONDITION REPORT FOR THE TASHMOO LANDING PIER

Prepared For: the Town of Tisbury
March 9, 2016

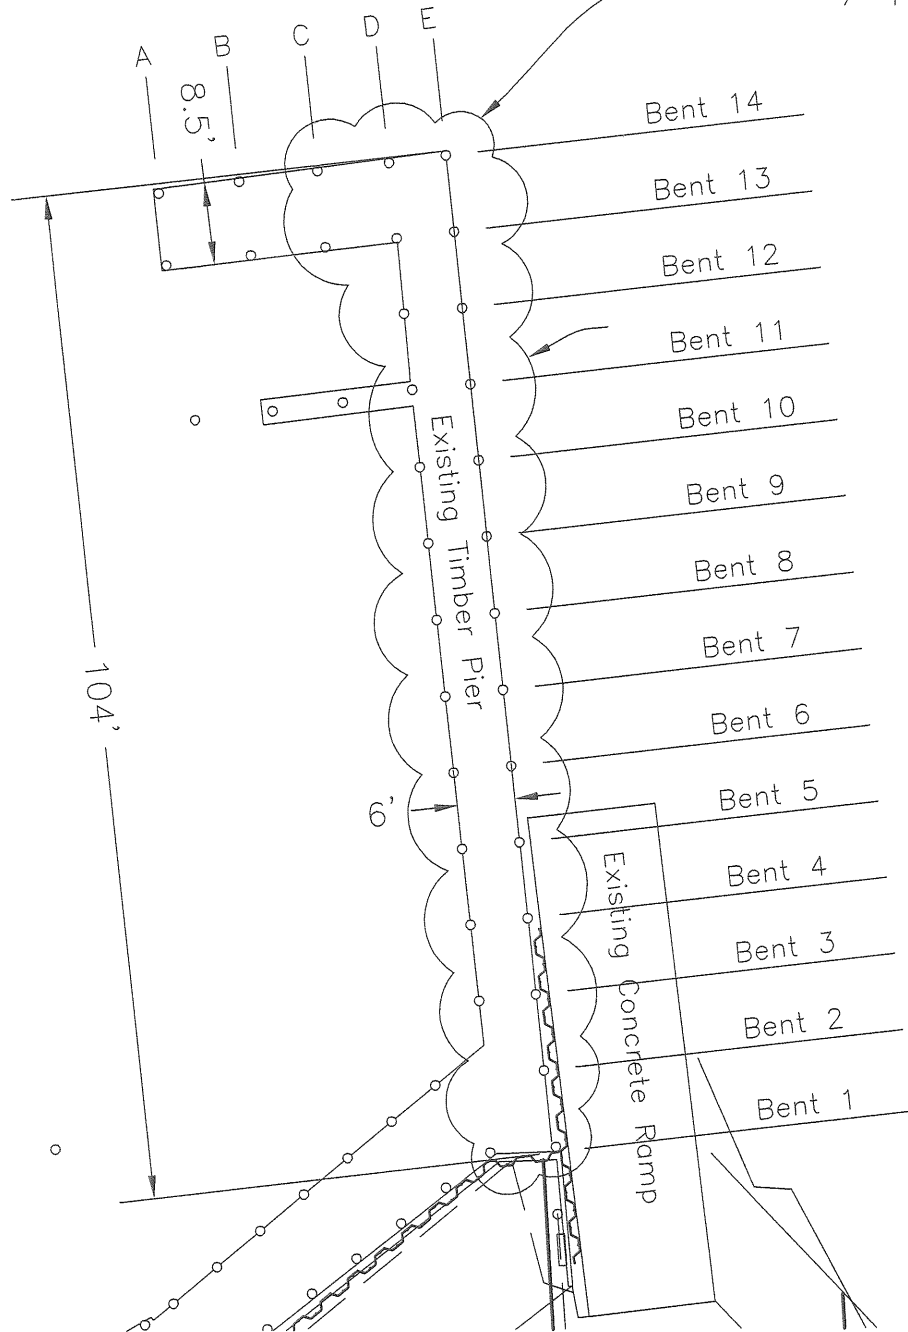
Recomended portion of pier to be re-built/replaced

It is this office's recommendation that most of the pier should be replaced. The attached plans show the recommended area for replacement and specifications that it should be built to.
