## Veterans Park Tisbury Retrofit Sites Field Summary Sheet

<b>Name: Causeway Rd 1</b>		<b>ID#: 1</b>
<p><b>Site Description:</b> Open turf area adjacent to path in Vet's Mem. Park (Park) off Causeway Road. Access via paved path from Causeway Road, sloping towards field. Soccer net storage on side, adjacent to isolated wetland area.</p> <p><b>Site Conditions:</b> Fair</p> <p><b>Proposed SCM Description:</b> WQ Swale for pretreatment overflow to wetland</p> <p><b>Existing or New SCM on site?</b> New</p>	<p><b>Site Location:</b></p>

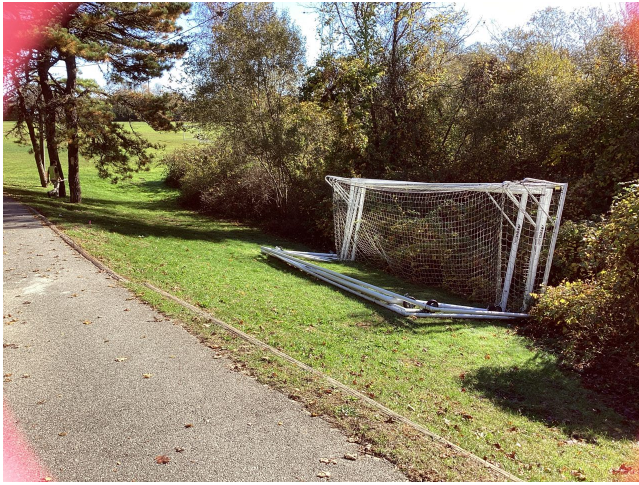
**Photo Caption:** View from entry point from road. Soccer nets on side.

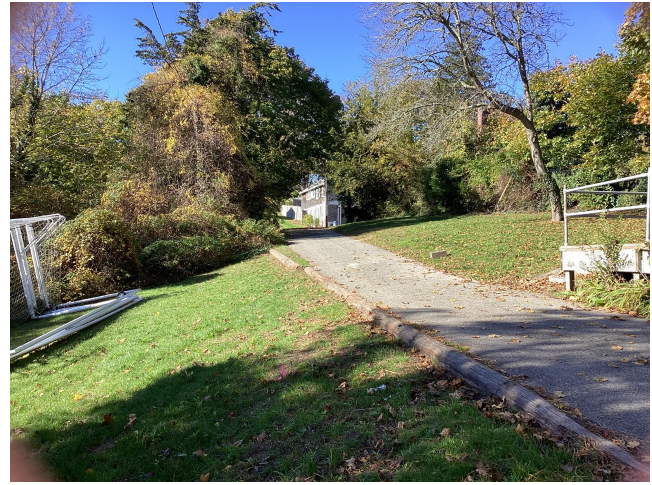
**Photo Caption:** View of entry path facing Causeway Rd.

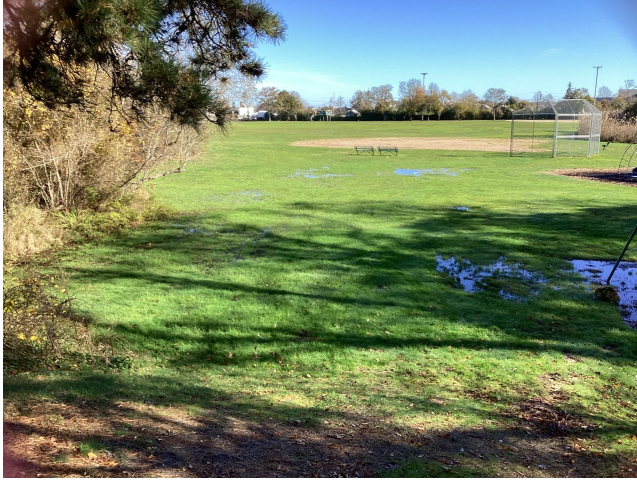
Name: Causeway Rd 2		ID#: 2
<p><b>Site Description:</b> Open turf ararea in park with playground equipment that floods regularly. Site slopes from Causway Rd to flat ara below, poor drainage evident and some trees.</p> <p><b>Site Conditions:</b> Poor</p>	<p><b>Site Location:</b></p>

**Photo Caption:** Standing water on field.

<p style="font-size: small;">Esri Community Maps Contributors, MassGIS, © OpenStreetMap, Microsoft, Esri, HERE, Garmin, SafeGraph, GeoTechnologies, Inc, METI/NASA, USGS, EPA, NPS, US Census Bureau, USDA</p>	
<p><b>Proposed SCM Description:</b> Constructed stormwater Treatment Wetland</p> <p><b>Existing or New SCM on site?</b> New</p>		
<b>RETROFIT DETAILS</b>		
<b>Project Candidate Score:</b> 3-Good		
<b>Proposed SCM:</b> Constructed stormwater sreament wetland.		
<b>Primary Non-Structural Controls:</b> Turf removal, native plantings around constructed wetland to provide habitat/connectivity to adjacent isolated wetland.

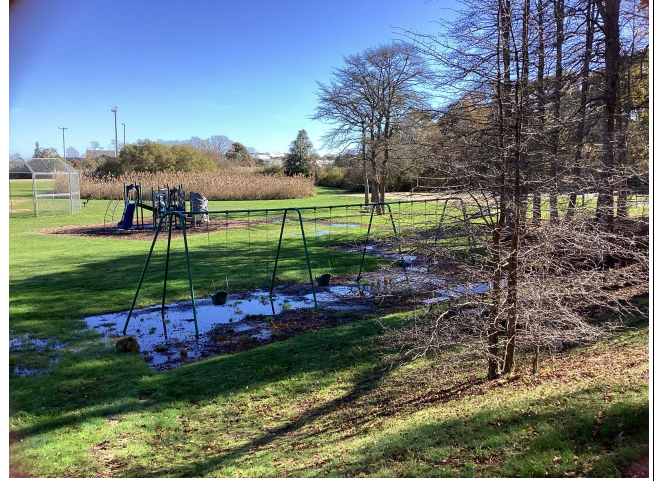
**Photo Caption:** Flooded area surrounding playground equipment.

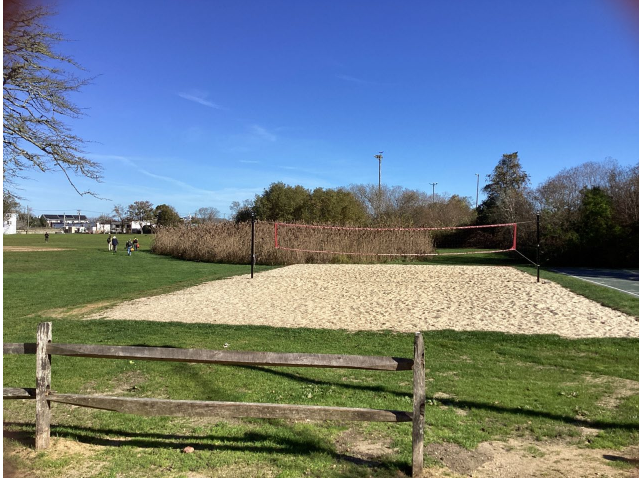
**Photo Caption:** Volleyball court with phragmites at northern end.

<p style="font-size: small;">Esri Community Maps Contributors, MassGIS, © OpenStreetMap, Microsoft, Esri, HERE, Garmin, SafeGraph, GeoTechnologies, Inc, METI/NASA, USGS, EPA, NPS, US Census Bureau, USDA</p>	
<p><b>Proposed SCM Description:</b> Relocate volleyball/basketball courts, divert WQv runoff from outfall to proposed constructed stormwater treatment wetland.</p> <p><b>Existing or New SCM on site?</b> New</p>		
<b>RETROFIT DETAILS</b>		
<p><b>Project Candidate Score:</b> 3 - Good</p>		
<p><b>Proposed SCM:</b> Constructed stormwater treatment wetland.</p>		
<p><b>Primary Non-Structural Controls:</b> Pavement and turf removal. Native plantings around constructed wetland to provide habitat/connectivity to adjacent wetland.</p>

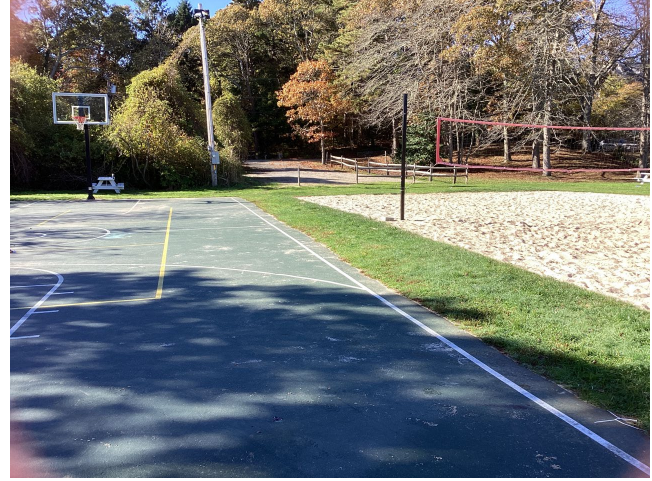
**Photo Caption:** View of basketball and volleybal courts facing Causeway Rd.

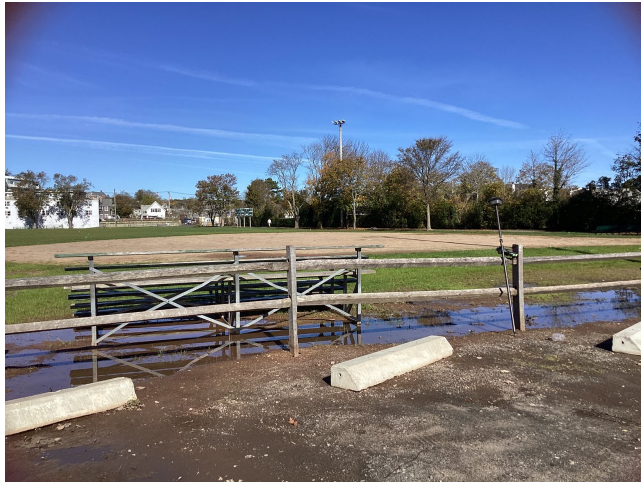
<b>Name: Lagoon Pond Rd Parking Lot</b>		<b>ID#: 4</b>
<p><b>Site Description:</b> This is a gravel public parking lot adjacent to baseball field, abutting wetlands. Puddles were observed along side adjacent to fields. Good opportunity for educational signage.</p> <p><b>Site Conditions:</b> Fair, poor drainage.</p> <p><b>Proposed SCM Description:</b> Parking lot bioretention island.</p> <p><b>Existing or New SCM on site?</b> New</p>		<p><b>Site Location:</b></p>

**Photo Caption:** View from parking lot facing the field.

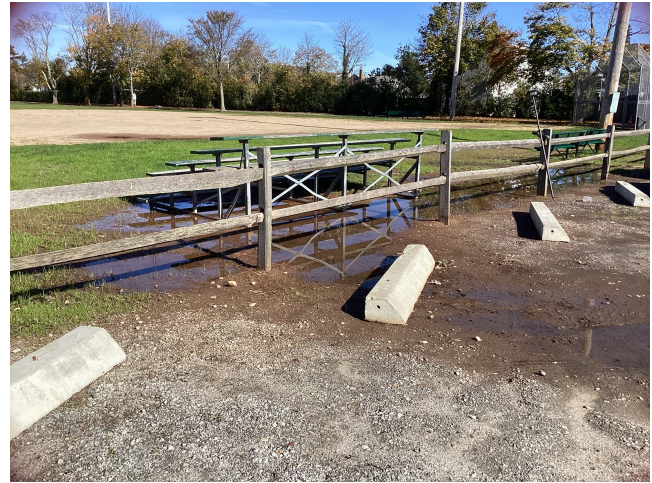
**Photo Caption:** View from entry of parking lot.

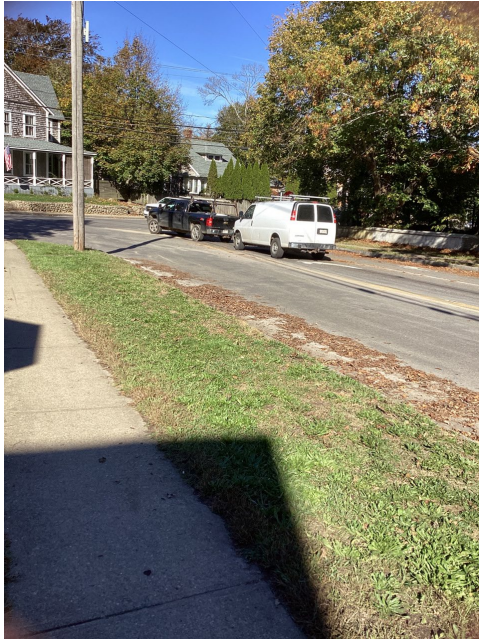
**Photo Caption:** View of right-of-way facing the intersection.

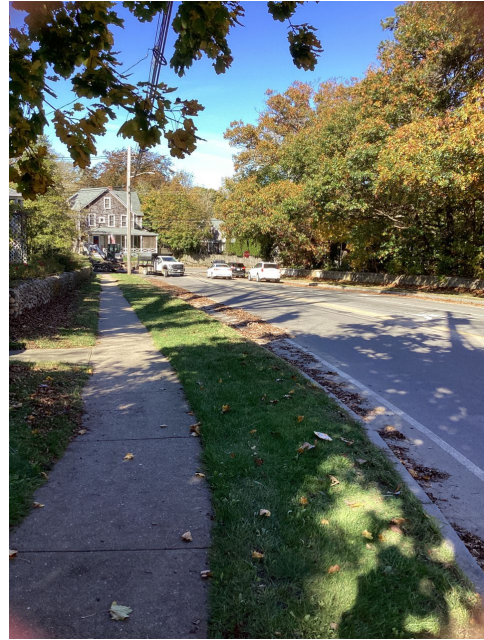
**Photo Caption:** View of right-of-way further uphill on Edgartown Road.

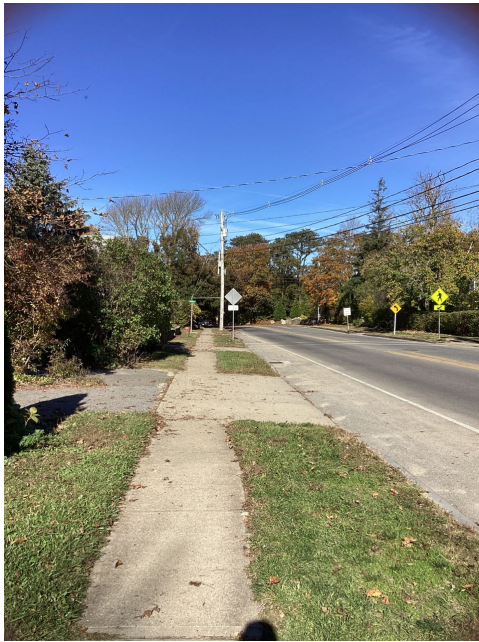
**Photo Caption:** Sidewalk and right-of-way on western side of Edgartown Road.

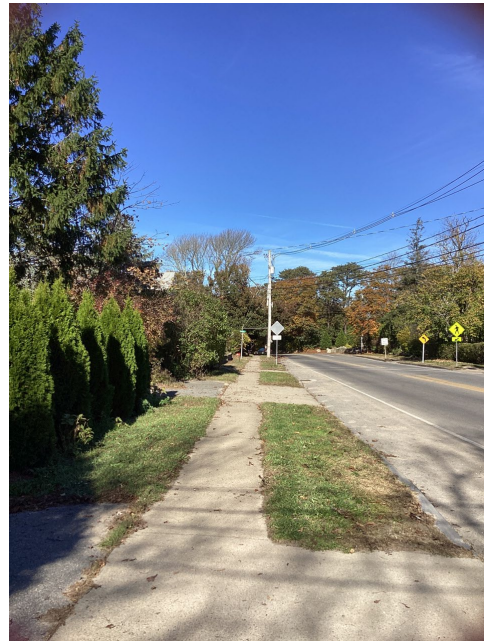
**Photo Caption:** Sidewalk and right-of-way on western side of Edgartown Road.

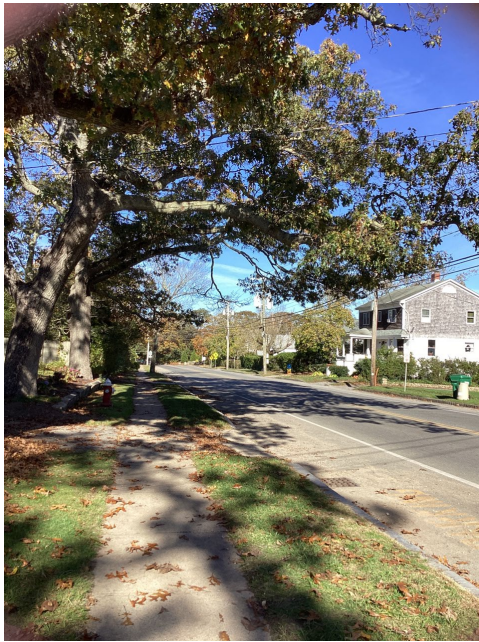
**Photo Caption:** View of street right-of-way along Edgartown Rd facing north. Tree branches and utility lines overhead.

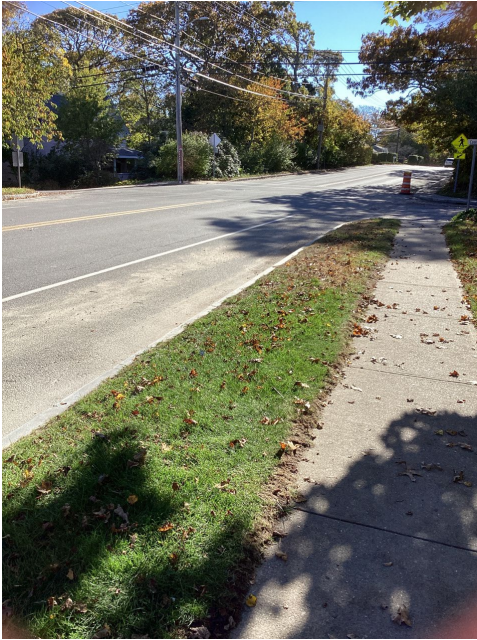
**Photo Caption:** View of potential tree trench area along western edge of road.

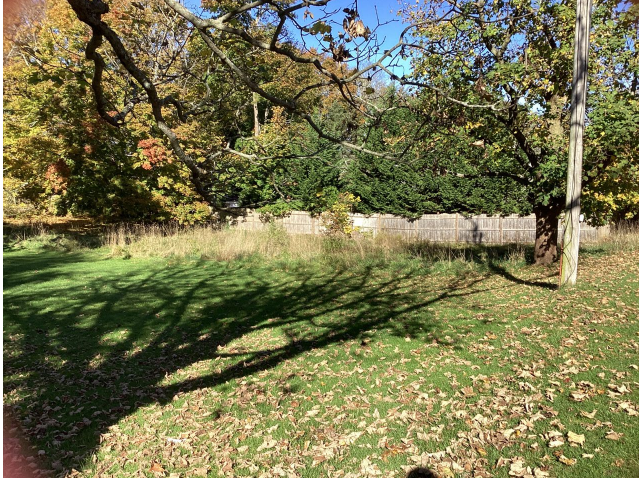
**Photo Caption:** View of parcel from road.

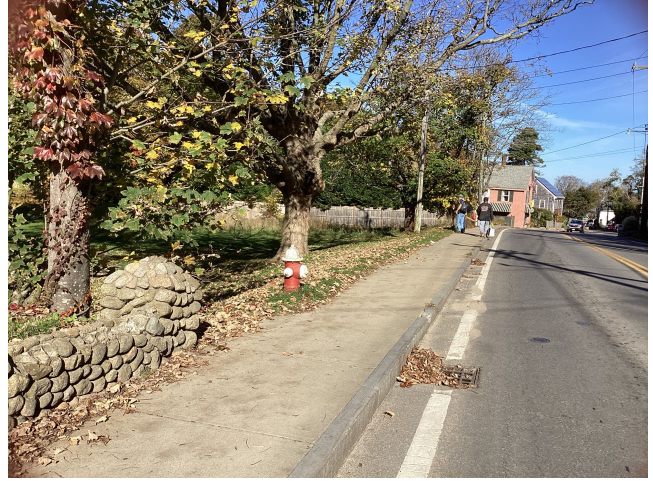
**Photo Caption:** View of parcel from road.

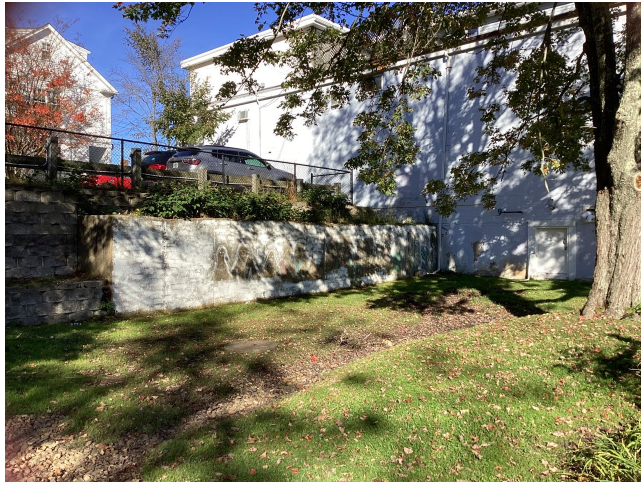
**Photo Caption:** View of low point area facing the upper parking lot of adjacent complex.

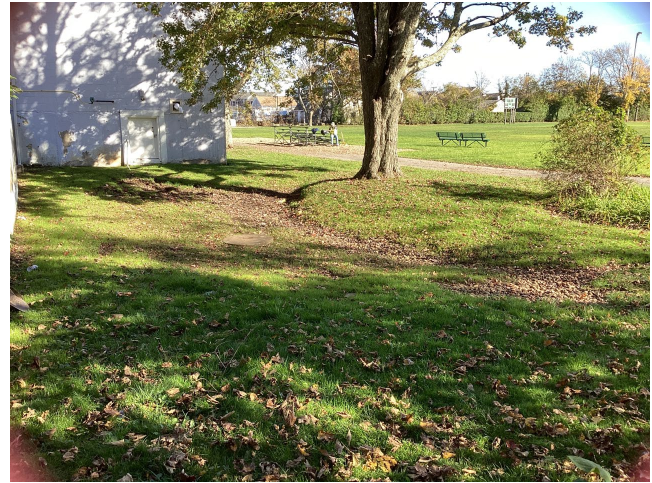
**Photo Caption:** Low point area facing the park.

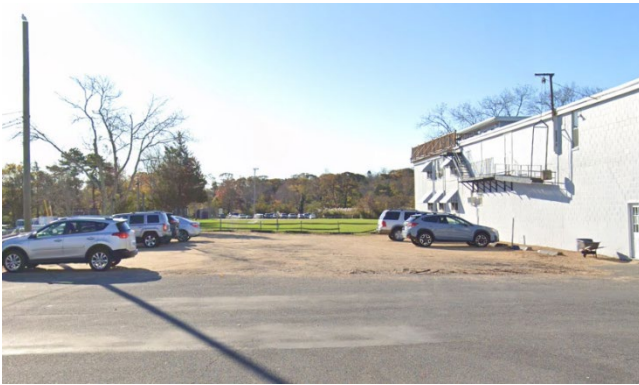
**Photo Caption:** View of Beach Street Municipal Lot from Beach Street

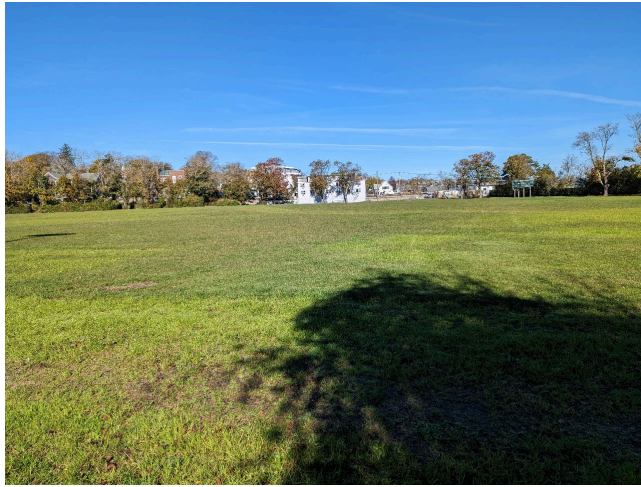
<b>Name: Entire Park</b>		<b>ID#: 12</b>
<p><b>Site Description:</b> The War Veteran Memorial Park fields become saturated with water to the effect that they are unusable for community sports activities. The park hosts a number of large events, including a car show and music festival.</p> <p><b>Site Conditions:</b> Poor</p>	<p><b>Site Location:</b></p>

**Photo Caption:** Baseball outfield.

<p style="font-size: small;">Esri Community Maps Contributors, MassGIS, © OpenStreetMap, Microsoft, Esri, HERE, Garmin, SafeGraph, GeoTechnologies, Inc, METI/NASA, USGS, EPA, NPS, US Census Bureau, USDA</p>	
<p><b>Proposed SCM Description:</b> Raise park surface and construct a shallow subsurface chamber system</p> <p><b>Existing or New SCM on site?</b> New</p>		
<b>RETROFIT DETAILS</b>		
<p><b>Project Candidate Score:</b> 4-Great</p>		
<p><b>Proposed SCM:</b> Subsurface chamber system. Profile to support turf grass uses, stormwater storage, potential organic layer for enhanced nitrogen removal. Reinforced turf possible for high-use/high intensity uses.</p>

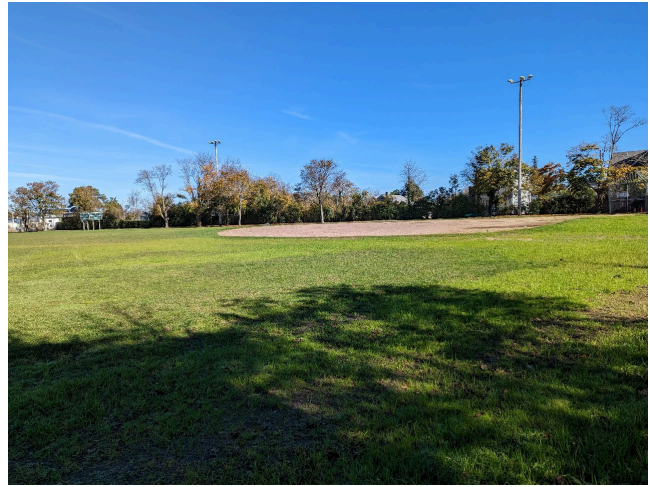
**Photo Caption:** Baseball field including diamond.
