Town of Tisbury Wastewater Department P.O. Box 788, 115 High Point Road Vineyard Haven, Ma. 02568 Phone (508) 696-4220 Fax: (508) 696-4221

Incident Report

Sanitary Sewer Overflow from a grinder pump station due to an illicit connection to the wastewater collection

system, resulting in wastewater entering the stormwater collection system and discharging to the harbor.

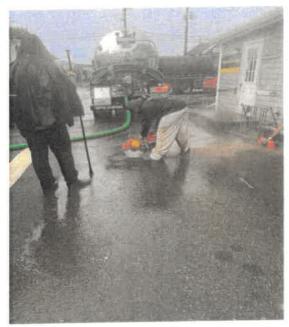
Grinder Chamber

When Mike arrived at the grinder pump station at 19 Beach Road, he immediately noticed water coming up from the Bilco Hatch that houses the grinder pump connected to the low-pressure sewer collection system. Once I received this information, I called Maciel and Son asking them if they could one of their trucks down to the area of 19 Beach Road and to bring what equipment he might need to cut the road to gain access to curb boxes that might have been paved over. Mike then informed me that the grinder pumps inside the chamber were completely submerged and not operating in auto and that he was manually pumping the chamber down, but it did not seem to be slowing the flow of water. When I arrived at the location, I began Looking of the location of the curb box. Mike then came over to assist in the search and said Kirk Metell was manually pumping down the chamber. Within minutes Maciel and son arrived and began pumping out the station with Mike. At approximately 15:00, the overflow was stopped from spilling out onto the property. Once the chamber was pumped down it was discovered that a large volume of water was coming into the chamber and that it was consistent with the type of flow that should becoming from any of the four-building listed on the as-builts. Catherine Blake who was previously on location also investigating the odor small went and retrieved and old title five map for the properties which gave us a better understanding. We discovered while using Maciels CCTV that the solids tank from the title five were still intact and attached to the sewer but was inaccessible due to paving. At this point I instructed Troy Maciel to cut the driveway and expose the tank so we can get a look at what was going on.
