Tashmoo Pond Dredging Feasibility Assessment

Town of Tisbury, Massachusetts

May 20, 2016

**DREDGING FEASIBILITY ANALYSIS
TASHMOO POND
TISBURY, MASSACHUSETTS**

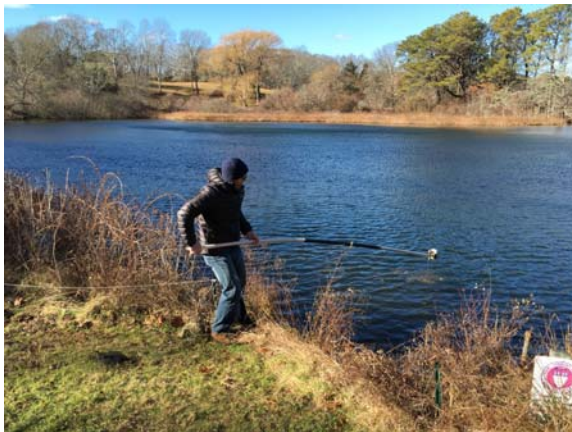
Photo 1. Near shore sediment sample collection.

During the field visit, HW collected a near shore sediment sample (Photo 1) to provide information on the physical characteristics of sediment in the pond bottom. The sediment sample was submitted to NETLab of West Warwick, RI, for laboratory analysis of grain size and total phosphorous.

HW's field observations and the laboratory grain size analysis of the near shore sediment sample indicates that the pond bottom in that area is comprised of brown sandy silt. The physical composition of the sediment is favorable for hydraulic dredging and sediment dewatering techniques, which are best suited for finer grained and organic materials. Sediment in the deeper portion of the Pond may include increased levels of organic material (i.e., decomposing vegetation and waterfowl excrement), but is expected to be similarly well suited for hydraulic removal and dewatering.
