Massachusetts Division of Marine Fisheries

Lake Tashmoo, Tisbury, MA

Eelgrass Survey

2022

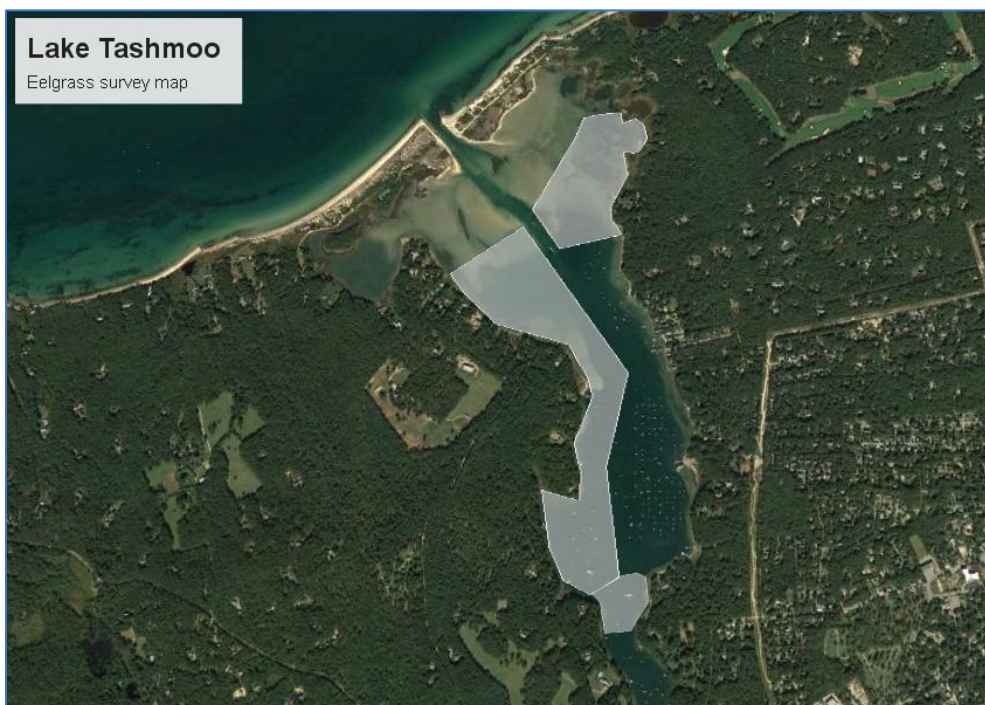
Figure 1. Eelgrass survey locations. Grey polygons represent the survey area of interest.

The Town of Tisbury provided MA DMF with a map delineating the survey areas of interest ([Figure 1](#)). MA DMF conducted a side scan sonar survey with groundtruthing at the proposed sites on June 11, 2021. Site conditions on the day were partly cloudy, calm and in the mid 60's F. The survey was conducted between 9:00AM and 1:30PM to coincide with an incoming tide, predicted for 1:15PM on the survey date ([Appendix B](#)). MA DMF biologists Dr. John Logan and Steven Voss conducted all side scan sonar and photo groundtruthing of the western survey area from a 20' DMF Maritime Skiff. Tisbury staff Danielle Ewart and MA DMF biologist Dr. Christian Petitpas conducted photo groundtruthing of the northern survey area from the Tisbury Shellfish Department skiff.

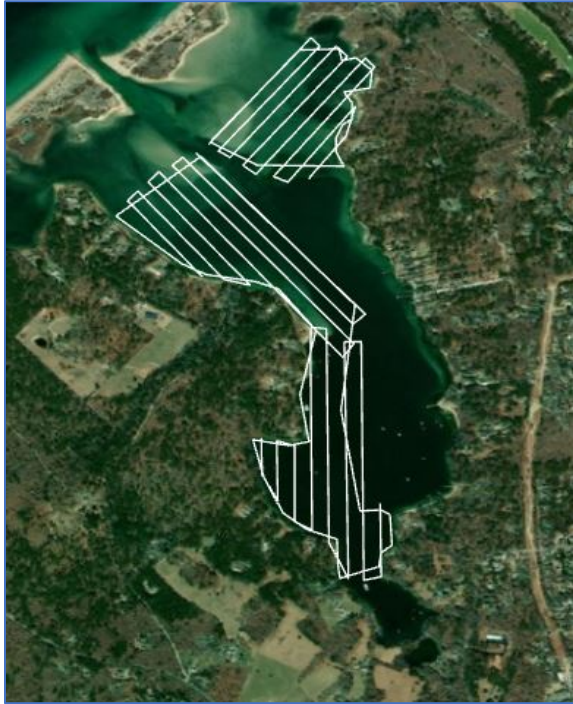
Figure 2. Transect lines developed to cover areas of interest.

to the Humminbird side scan system using the proprietary software HummViewer. The transect lines (Figure 2) were organized and renamed in the Humminbird display unit for convenient access once in the field. Side scan data were recorded along the planned lines at a speed of 3 to 4 kts. The Humminbird system includes a display and data collection unit on which the transducer data can be recorded to an SD card. Side scan sonar data were processed on a PC and then exported as GeoTIFF images.
