Vineyard Land Surveying & Engineering, Inc.

CONDITION REPORT FOR THE TASHMOO LANDING PIER

Prepared For: the Town of Tisbury
March 9, 2016

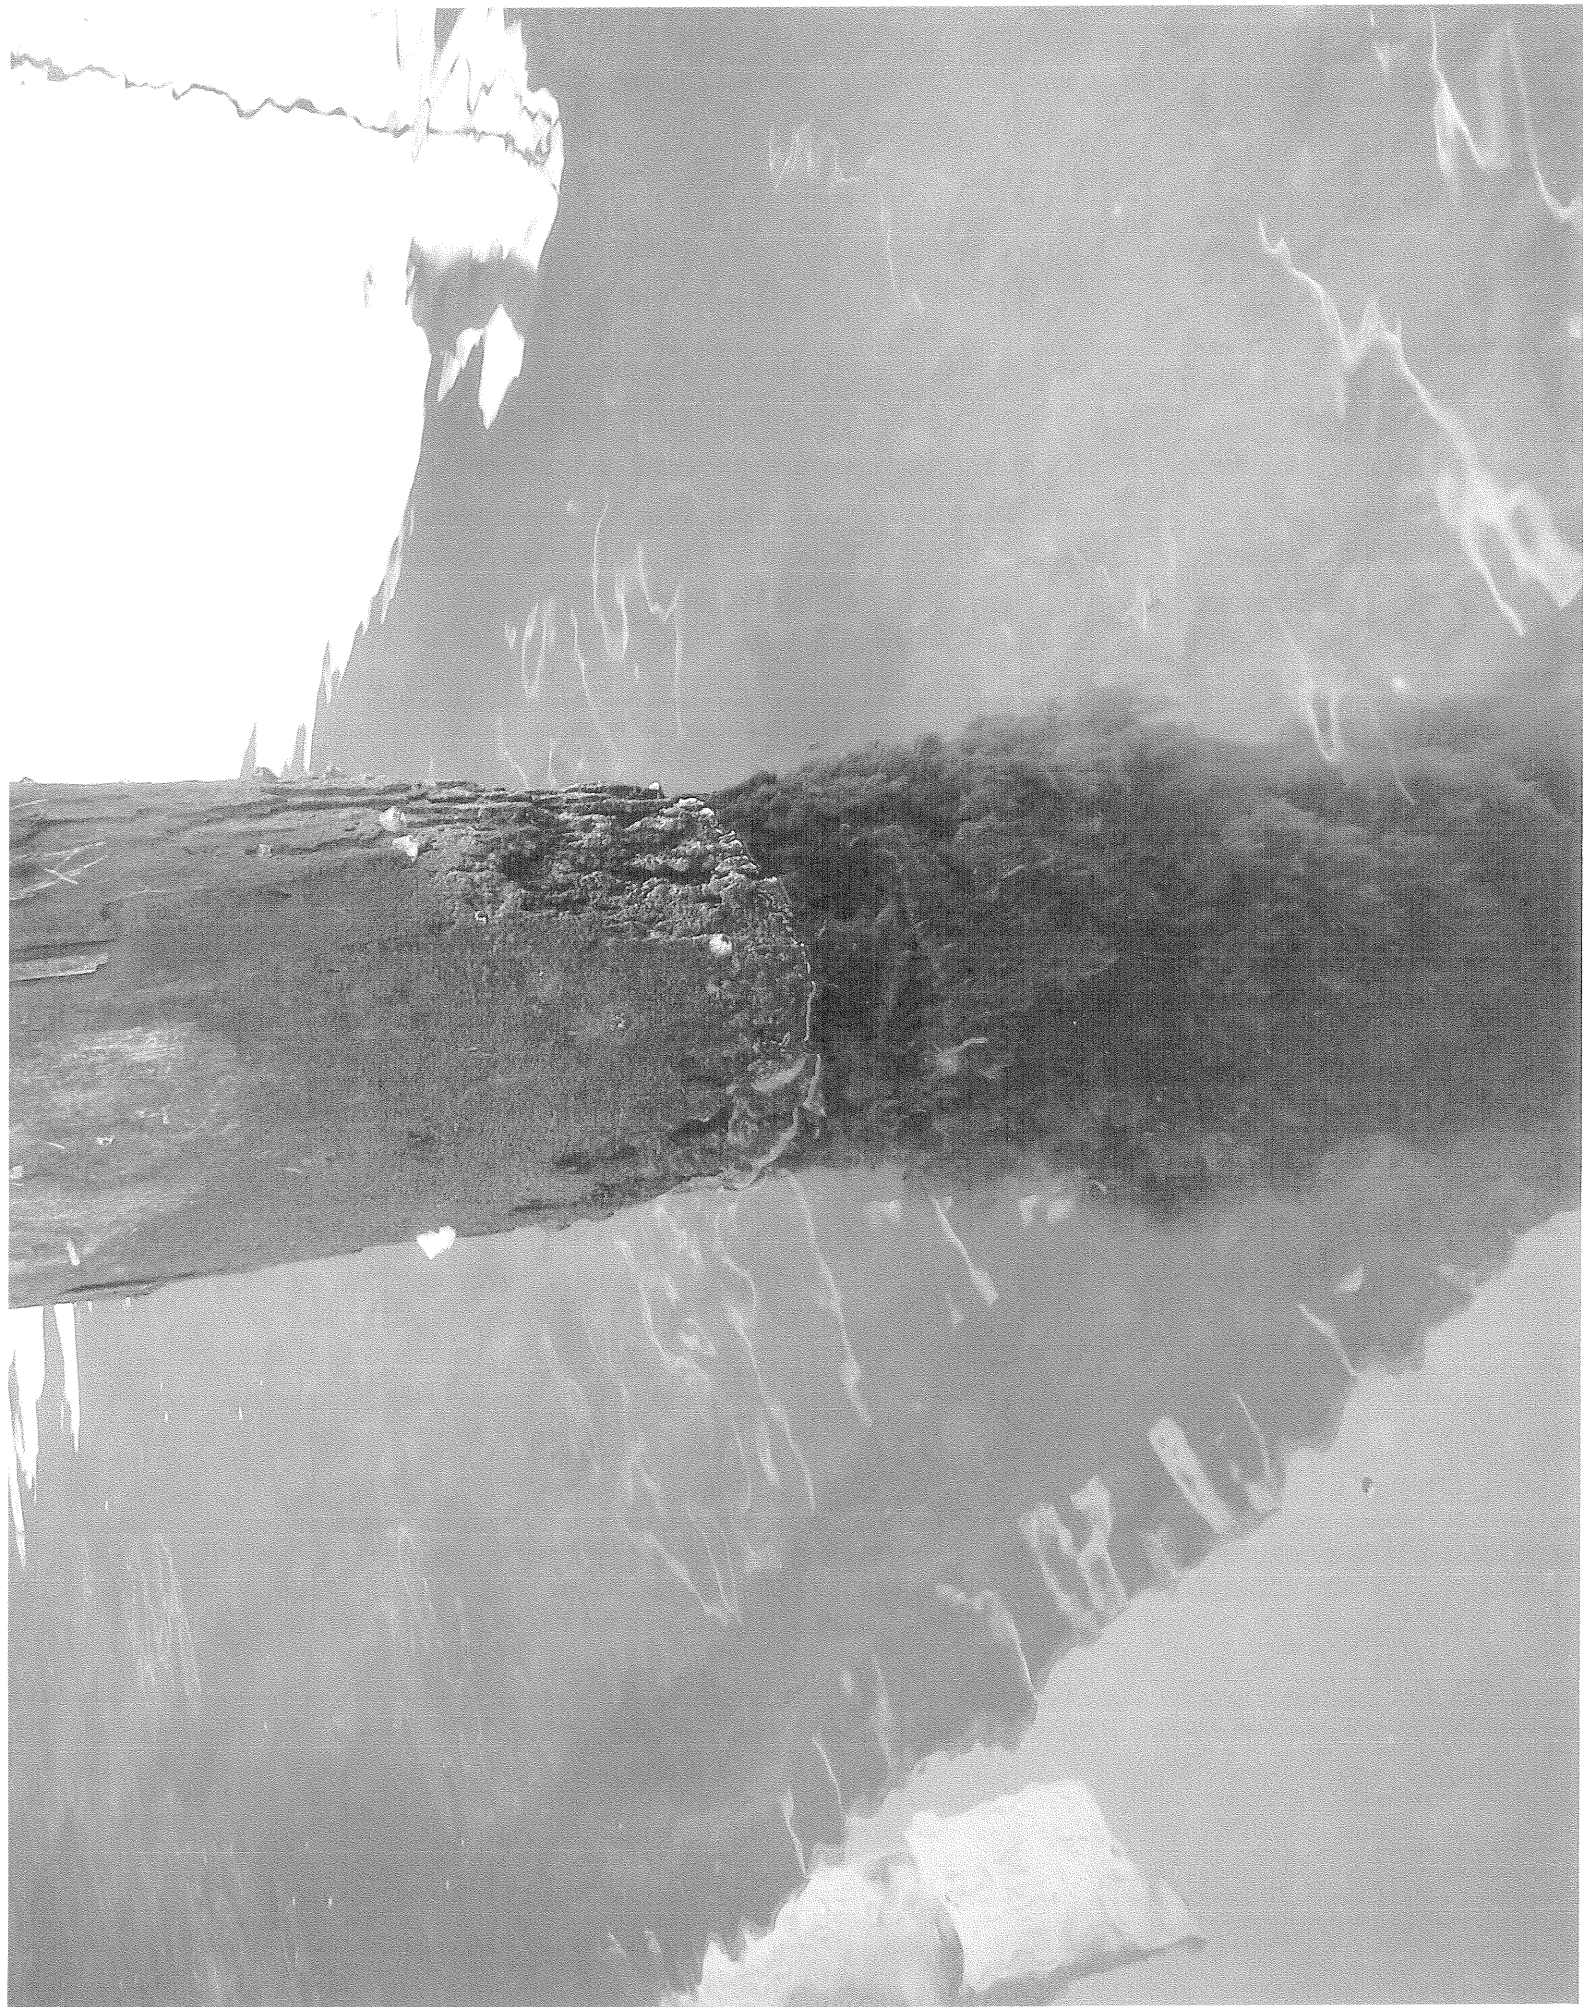
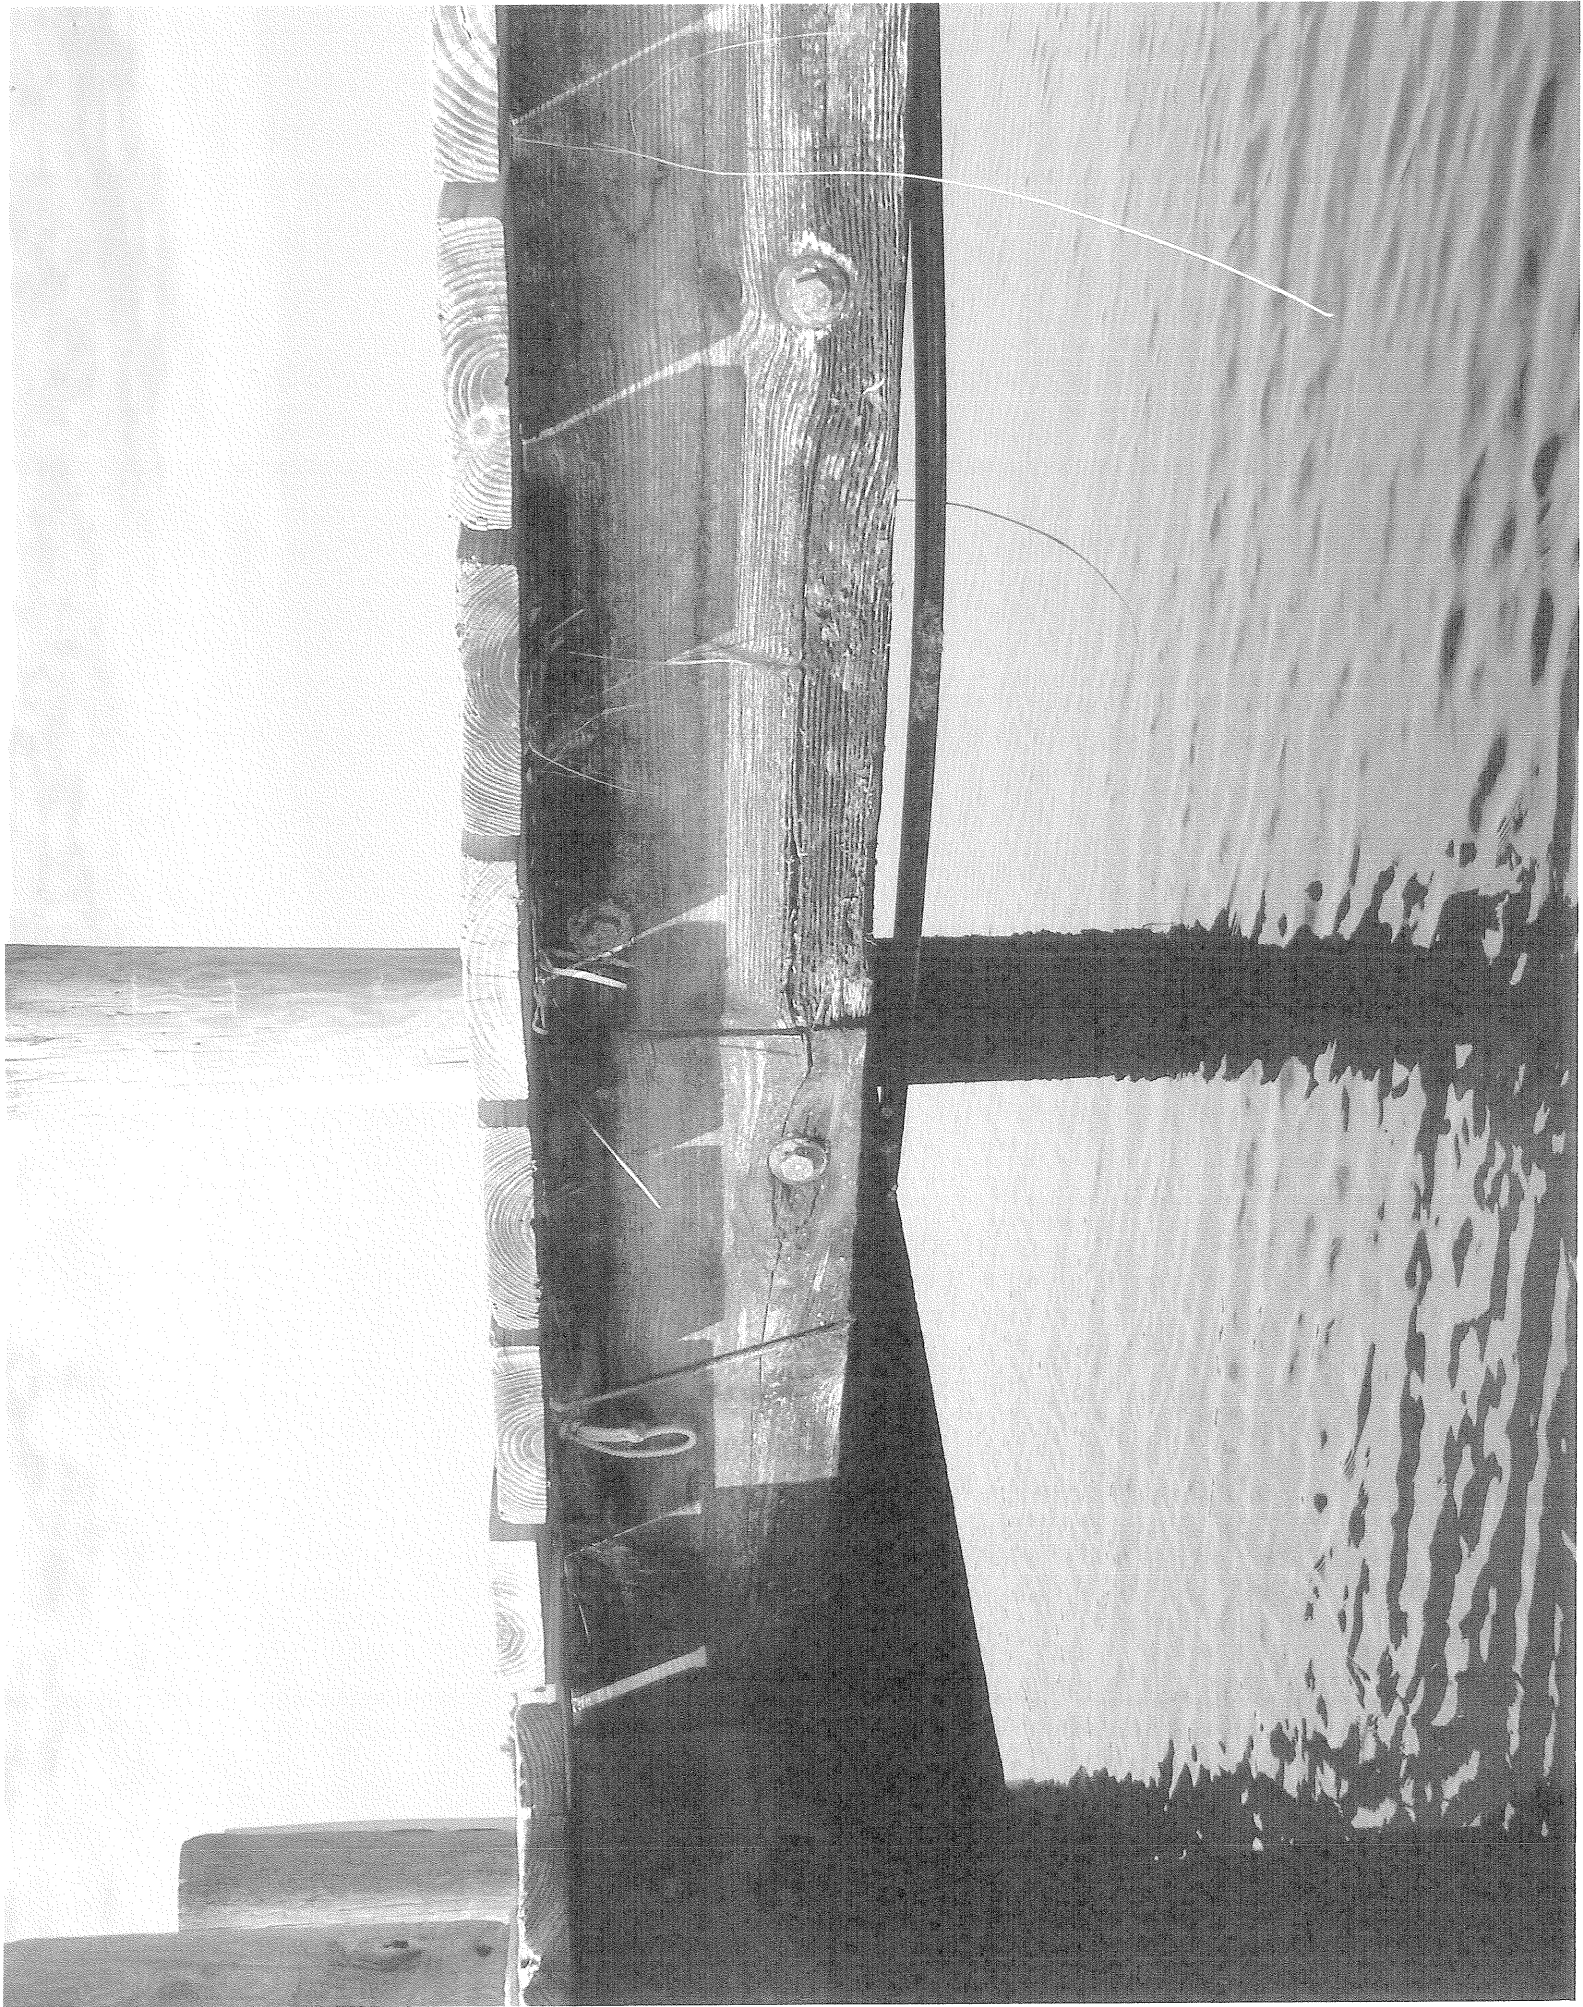
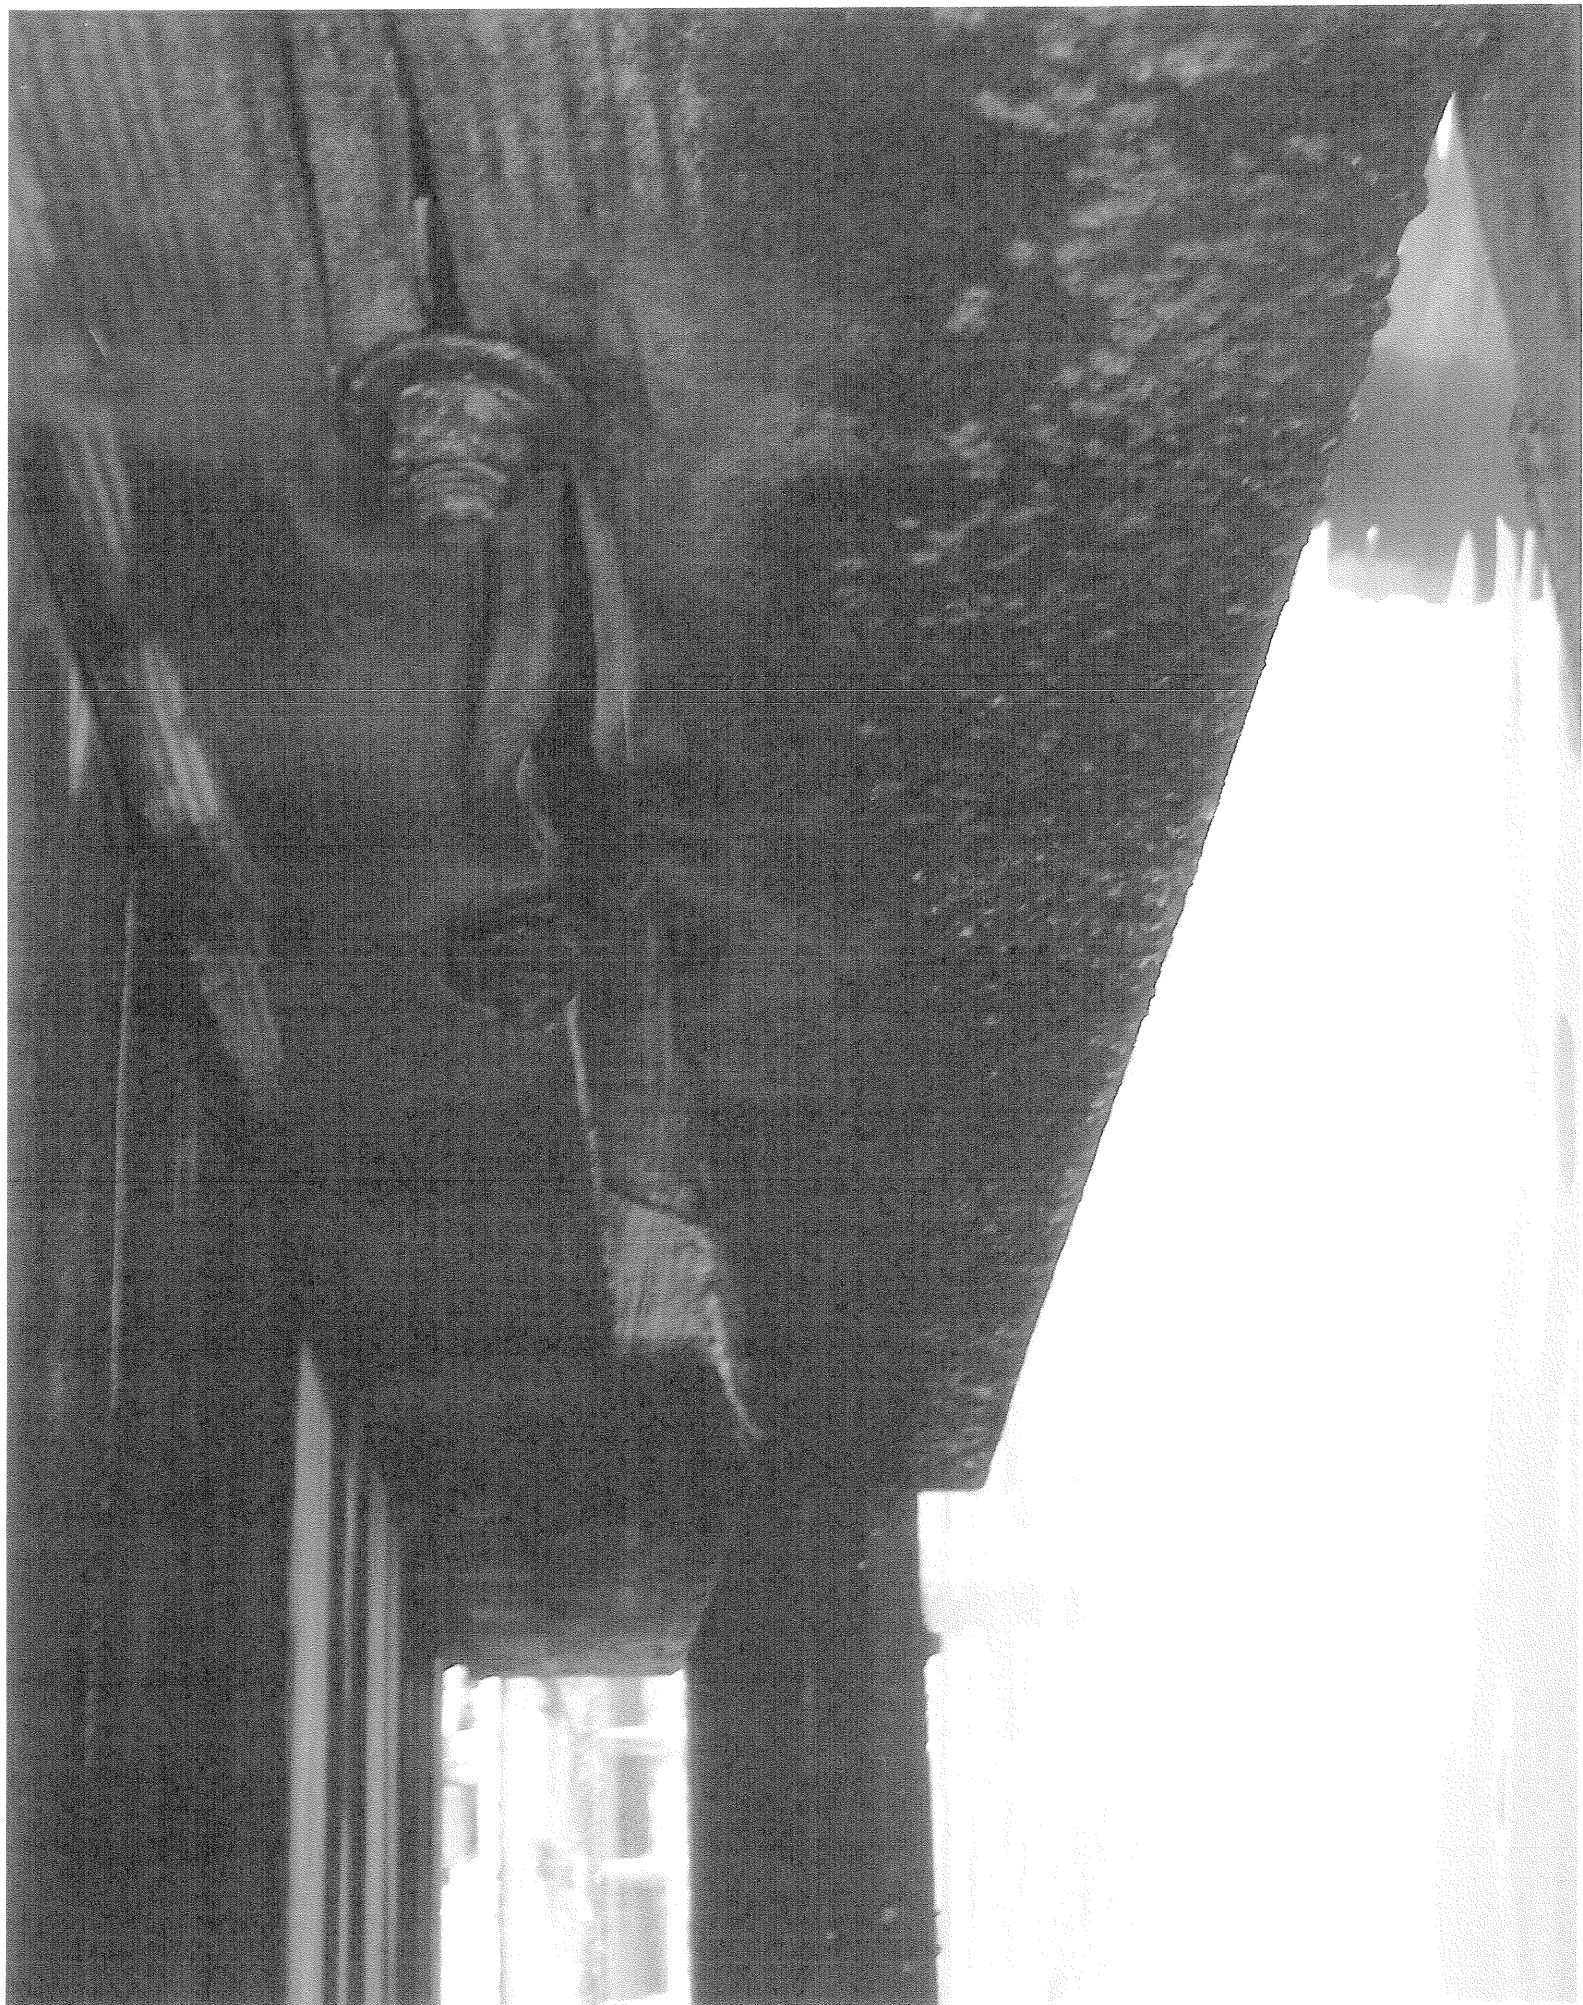
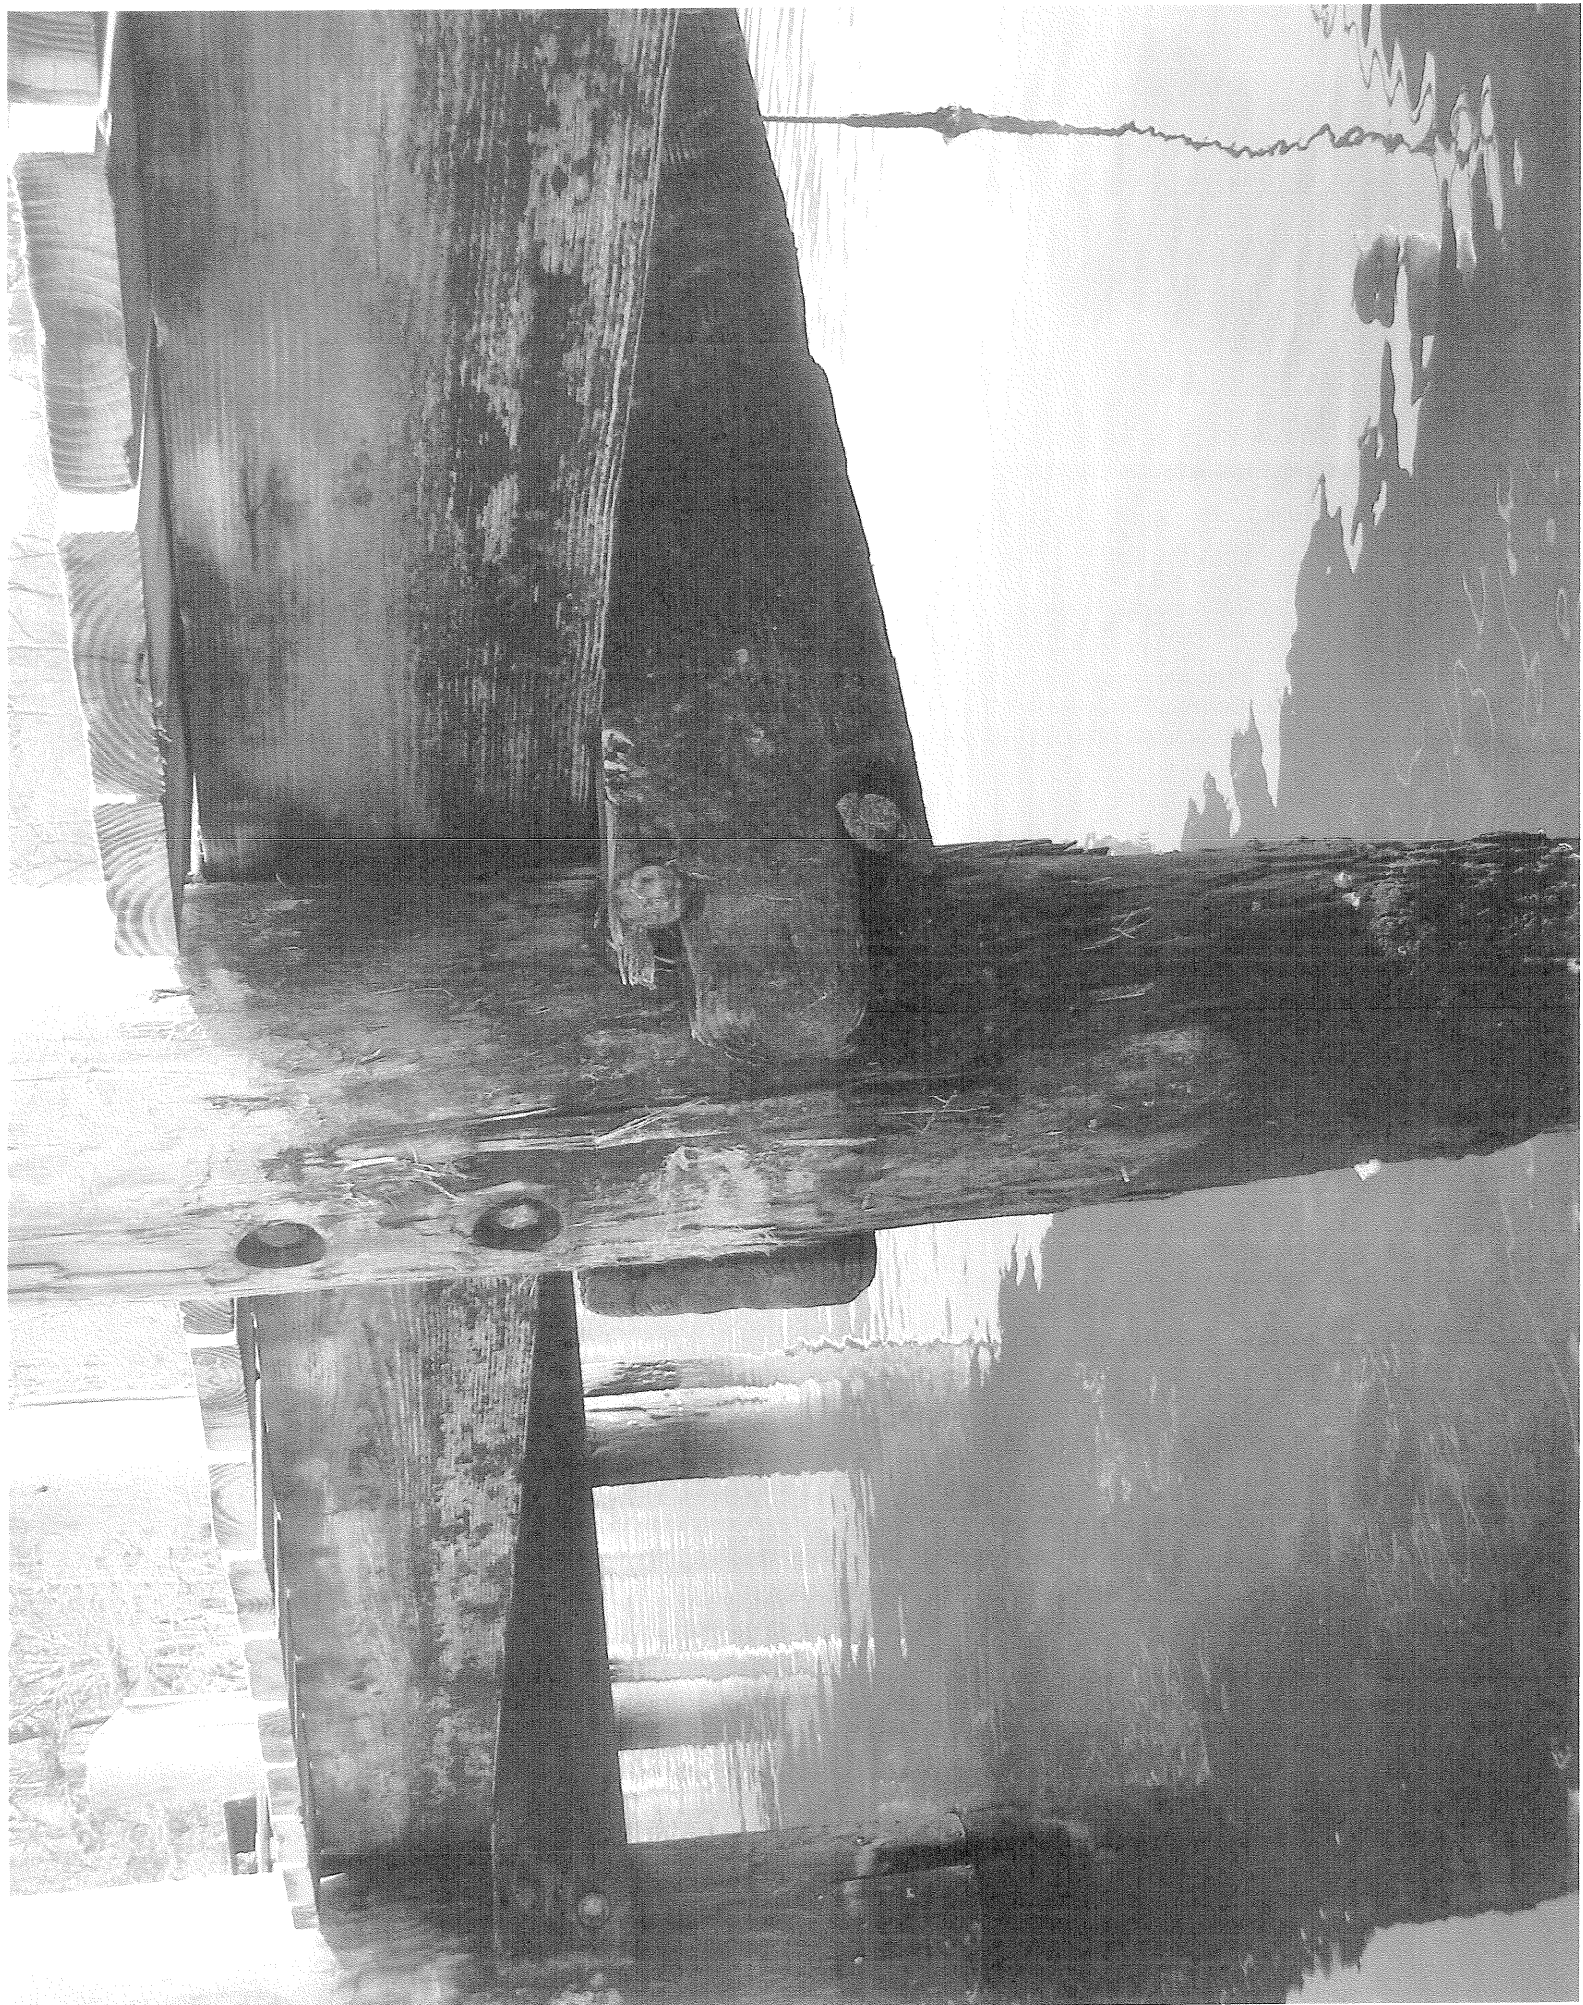
Photographs of existing conditions

The deck boards are generally in sound condition but are starting to show some signs of wear. The nail fastenings however, are in poor condition and many have deteriorated to the point of failure. Currently, many of the deck planks can be lifted out of place by hand.

The headers are 2 ½" X 9 ½" timbers are generally in poor condition. Many of the timber ends show signs of significant rot and many are split at the bolt-to-pile connection. The splitting is occurring due to the reduced strength of the wood as it rots.

There are 6 pressure treated piles in good condition at the south end of the "TEE" and the south end of the finger pier. The rest of the piles are either in poor condition or very poor condition. These piles show significant narrowing at the mud line, de-laminating, hollow cores, and damage. Some holes are big enough to insert the head of a hammer, one pile had a hole through to the opposite side.

Many of the piles have deteriorated badly enough that they can no longer provide any lateral support. This means any lateral resistance of the pier needs to be transferred through the structure to other piles. This pier has become more flexible over the years and these conditions have accelerated splitting of the headers and failure of the butt splices. A heavy boat hitting the pier or tied to the pier during a storm could cause excessive damage.

Renovation of the pier In the near future is recommended to replace many of the piles, stringers and joists that are in poor condition. Some of the stringers and decking could be saved and reused, however an evaluation of cost benefits should be done at the time to determine if it would be more efficient to replace them when all the other work is being done. In the event, the decking and stringers are to be reused, it is recommended that the timber be re-fastened with stainless deck screws of suitable size.

It is this office's recommendation that most of the pier should be replaced. The attached plans show the recommended area for replacement and specifications that it should be built to.
